## Impact of welding steel rod rotor bars on ripple mill efficiency and cost-effectiveness at Sumatera Jaya Agro Lestari Sawit Coconut Plant

PT. Sumatera Jaya Agro Lestari is an industry that is moving in the field of coke processing, some long processes that include loading ramp, sterilizer, thresher, digester, pressing, clarification, and kernel plant stations, some problems that occur in the kernel stations mainly to efficiency results on the ripple mill machine, not out of the operation and maintenance standards performed by using the achievement of the target of the kernel by the efficiency standard of 96%, on ripple mill machines often occur cwrnouteson steel rod due to the input of the ripple mill too over load, and the amount of nut less mature, for that was done a study on steel rod that has already worn out by performing the re-welding method, i.e. the addition of the meat of the steel rod to 5 mm of the surface of the rotor-disc to obtain the maximum effectiveness result. The steel rod is the most important part of the mill ripple machine consisting of stone mills that move automatically so that it will not reach the maximum efficiency result at mill mills ripple rod. W

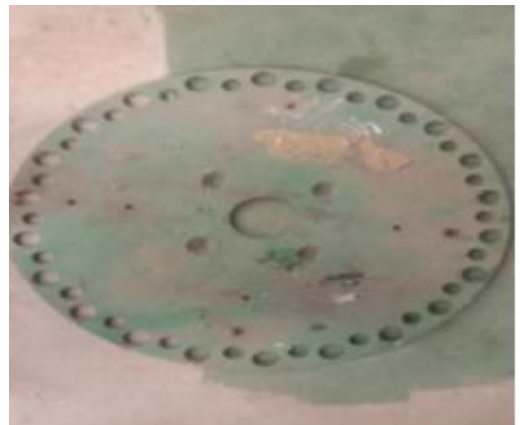
Fig. 2. Rotor disc(source: PT. Sumber Jaya Agro Lestari).

The rotor disc is one of the components of a rotor bar that determines the position of the bar (Fig. 2).

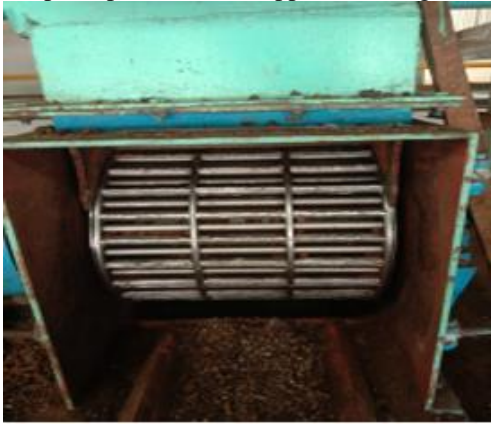
Fig. 3. Rotor bar (source: PT. Sumatera Jaya Agro Lestari).

Rotor bars are pile-shaped axes around rotors used to place palm seeds in ripple mills. Rotor bars are pile-shaped axes around rotors used to place palm seeds in ripple mills (Fig. 3).

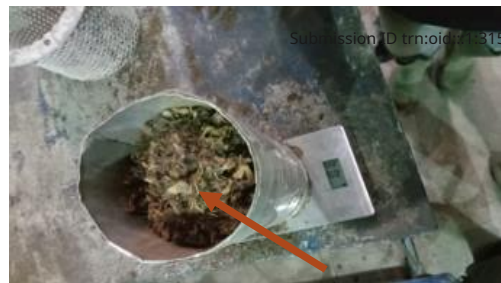
In the operation of the ripple mill that passed the recommended service life of the manufacturer. Therefore, there is a need for rigor to be able to analyze, select and use effective tools in the process to find optimal processing costs with good performance so that it can be a good input to the palm coconut plant. The method used to obtain research data is to take samples 1 and 2 by taking 1 kg of kernel nut. 1 kg is one sample placed on the kernel nut filling with a note that should not be too much resulting in the steel rod suffering depletion so that the square bar is dull and the rotor bar is bent overwhelming the breakage ineffective (Fig. 5).

Fig. 5. Samples before welding.

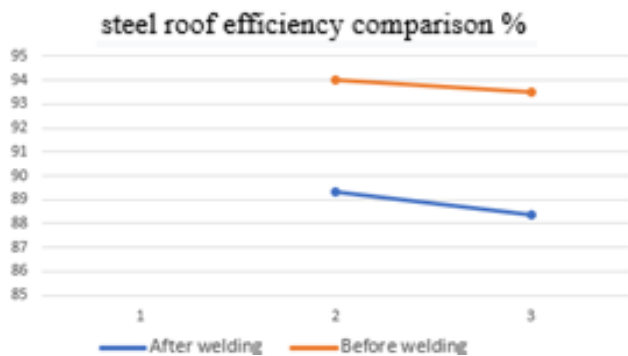
The analysis of the impact of welding steel rods is more efficient than the steel rod that has been worn-out and the results

Fig. 12. Comparison of efficiency before and after welding.
